PROFESSIONAL RESERVE STUDY

Lake of the Woods

14218 - 134th Street KPN, Gig Harbor, WA 98329

May 29, 2024

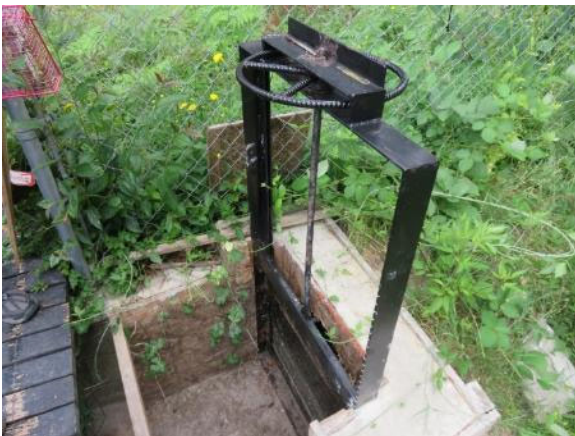
There is a slide gate at the outfall of Doyle Pond that was constructed by one of the Board members. This slide gate is hand operated and constructed of steel. We have assumed that this slide gate will be periodically repainted and otherwise maintained via routine maintenance. Therefore, no funding has been allotted for this slide gate in the future.

Slide Gate (Photo from 2017)

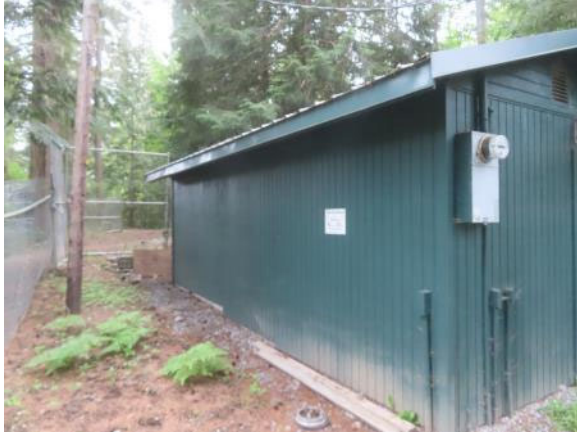
Pump House #2

Well house #1 has power coated metal siding, while the other buildings have either T1-11 plywood siding or wood siding as well as wood trim. We have budgeted for exterior painting of these buildings every 5 years.

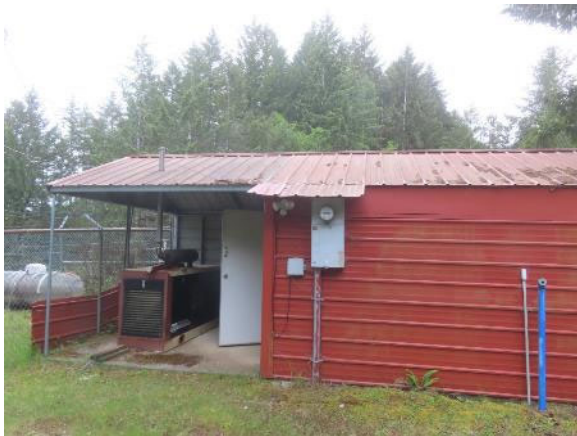
Pump House #1

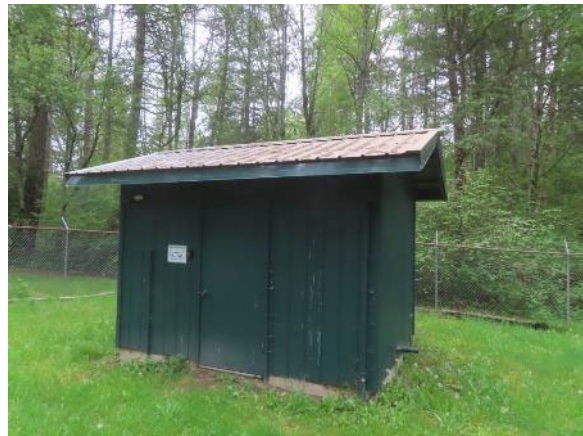
Pump House #4

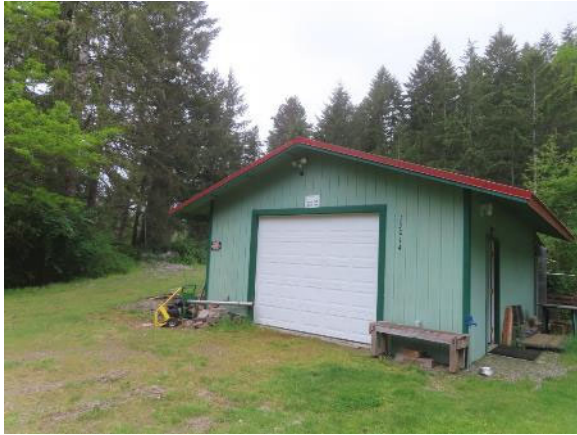
Maintenance Shed

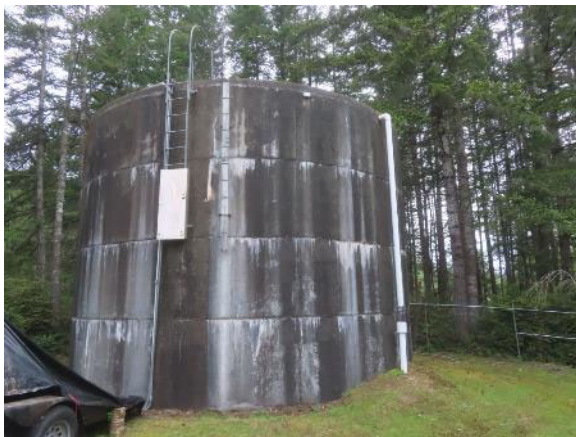
Concrete Water Storage Tank

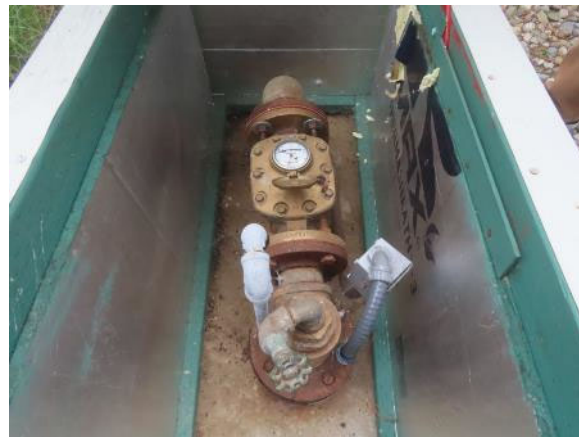
Well Head #3

We have budgeted for well pump #3 and well pump #4 to be replaced in 2025. We recommend that the old well pumps for well #3 and #4 be salvaged, if possible, to serve as emergency back-ups. If they are not salvageable, a separate back-up well pump should be purchased and stored on-site. We assume that typical maintenance and possibly rebuilding well pumps will occur occasionally and be paid for via routine maintenance.

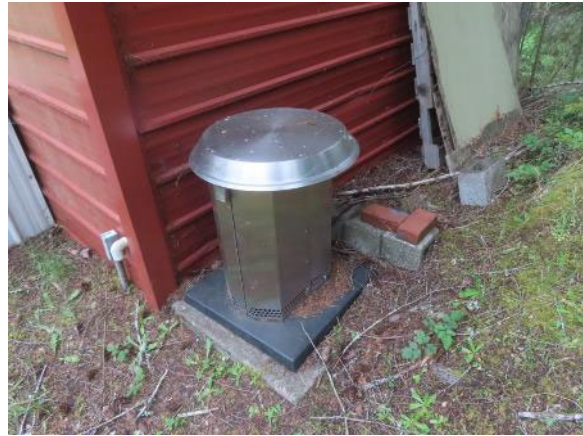
There is an aerator that was installed for Doyle Pond in 2013. We have assumed that this aerator will have a total lifespan of 15 years prior to replacement.

Aerator

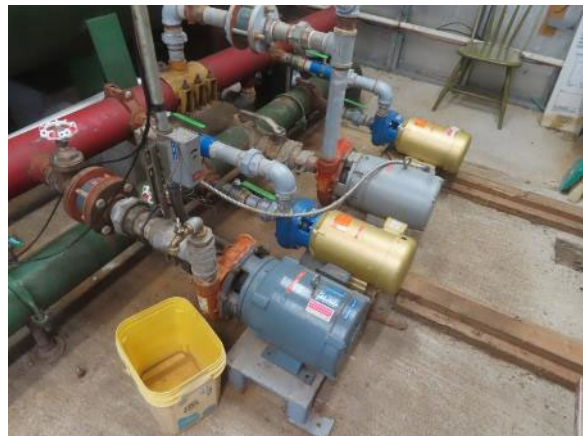
4 Booster Pumps (of which 2 are older back-ups)

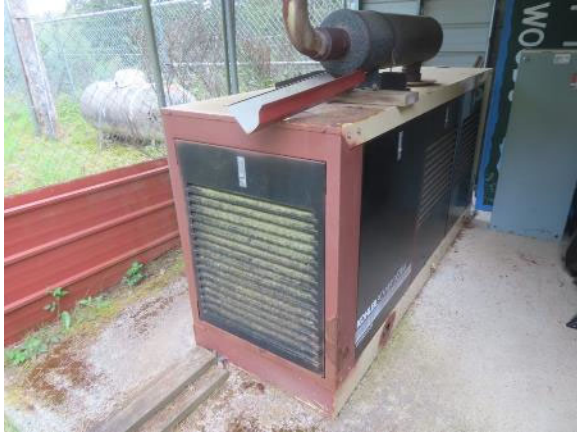
There is one back-up generator in this development adjacent well house #1, plus a second back-up generator that has been purchased in 2024 that will be installed adjacent well house #2. These generators should be exercised as recommended. We understand that the generator and transfer switch at well house #1 was installed in 1997.

Electrical Generator at Well House #1

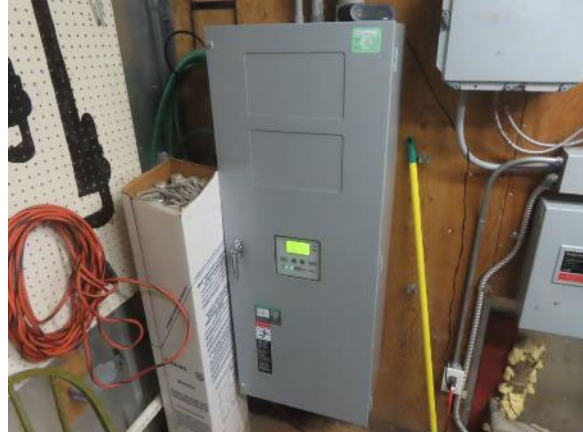
Transfer Switch for Electrical Generator at Well House #1

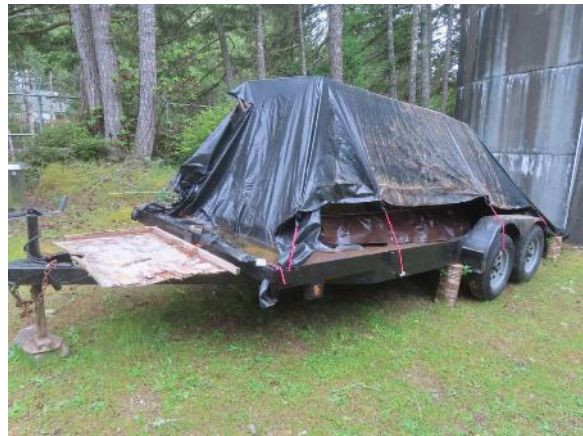
New Generator to be Installed at Well House 2

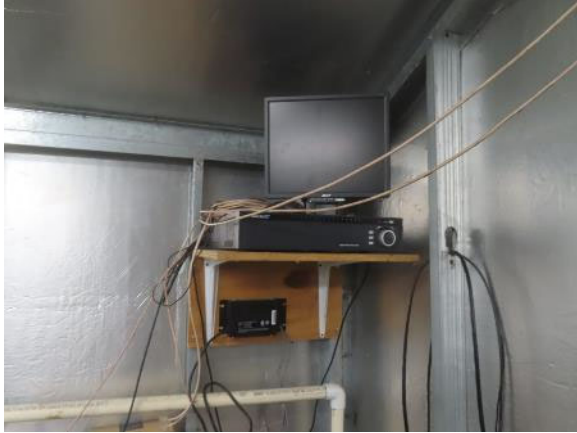
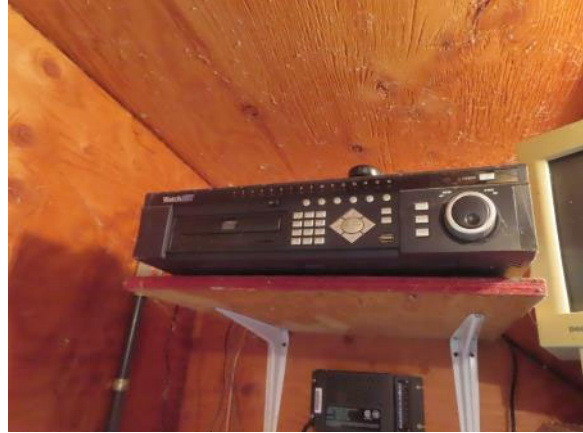
There is a surveillance system on this property with recording equipment and monitors located at the pump houses and other strategic areas. We have budgeted for an upgrade of the surveillance equipment of \$7,000 in 2024 and every 5 years thereafter.

Surveillance System Recording Equipment and Monitor

Surveillance System Recording Equipment

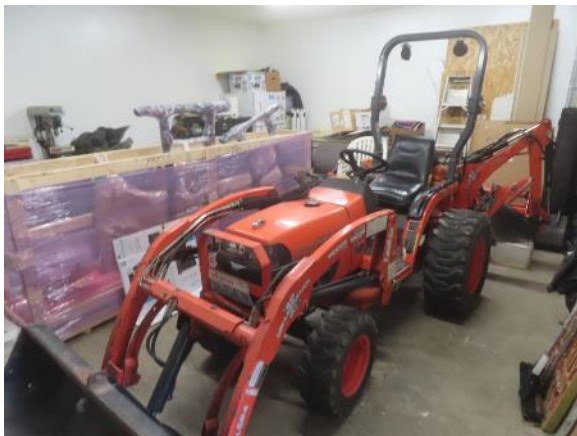
The Association owns a Kubota tractor. We have assumed that the tractor will have a total lifespan of 20 years prior to being replaced. Additionally, there are several attachments that came with this tractor. We have separately budgeted for replacement of the mower attachment every 20 years.

Kubota Tractor

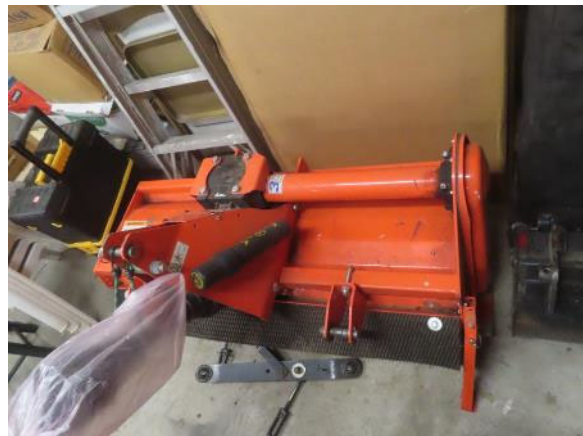
Mower Attachment

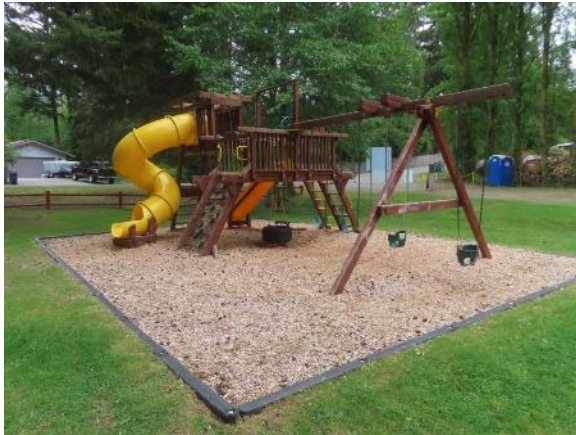
There are two separate playground areas in this development. The larger playground is in Pete Rix Park and has a playground set that was replaced around 2009, plus an older swing set and two picnic tables. There is also an older playground set on the other side of the development adjacent to the basketball court. We have assumed that painting, staining, and general maintenance will occur on this playground equipment as part of general maintenance to extend the total lifespan of this equipment to 25 years.

Newer Playground Set

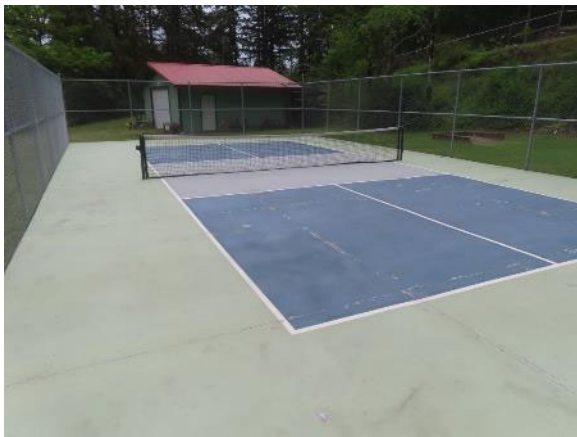
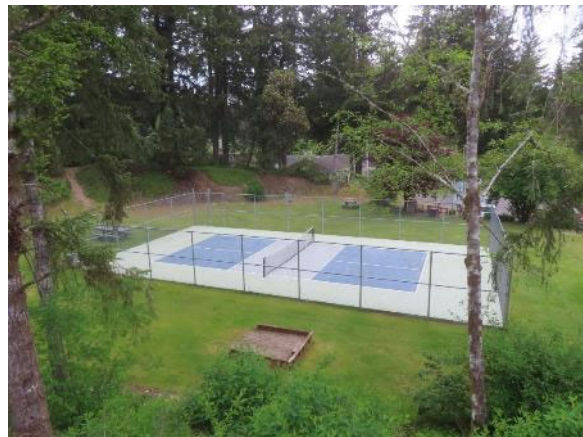
There is a pickle ball court in this development that we understand was last resurfaced in 2023. We have budgeted for this resurfacing to occur every 10 years.

Pickle Ball Court
